# Lessons Learned in Thermal Coatings from the DSCOVR Mission

*Nithin S. Abraham*

*NASA Goddard Space Flight Center, Greenbelt, Maryland 20771  
Code 546 Contamination and Coatings Engineering Branch*

2015 Contamination, Coatings, Materials, and Planetary Protection (CCMPP) Workshop  
NASA Goddard Space Flight Center, Greenbelt, Maryland, 20771 United States  
Wednesday, July 29, 2015 to Friday, July 31, 2015

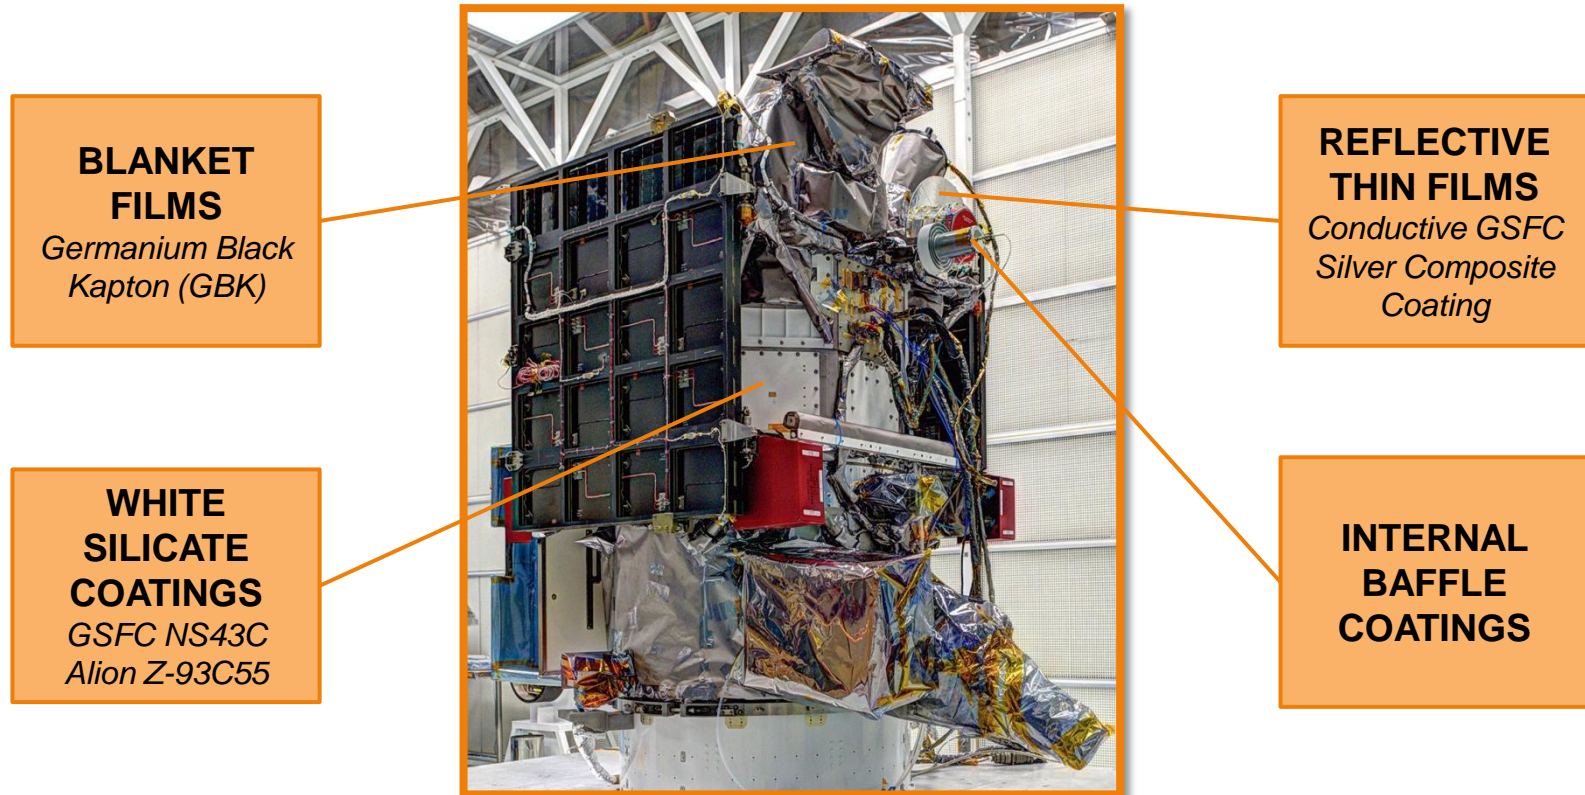
- Serves as a passive thermal control system on the spacecraft
- Provides **thermal**, **optical**, and/or **electrical charging** properties to meet mission requirements while surviving the harsh space environment

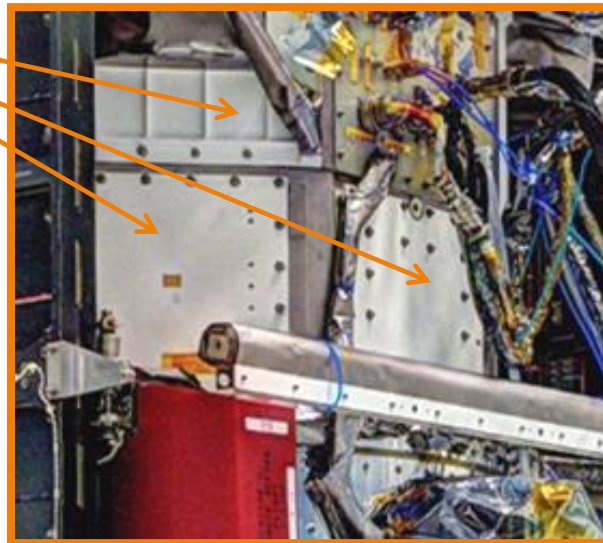
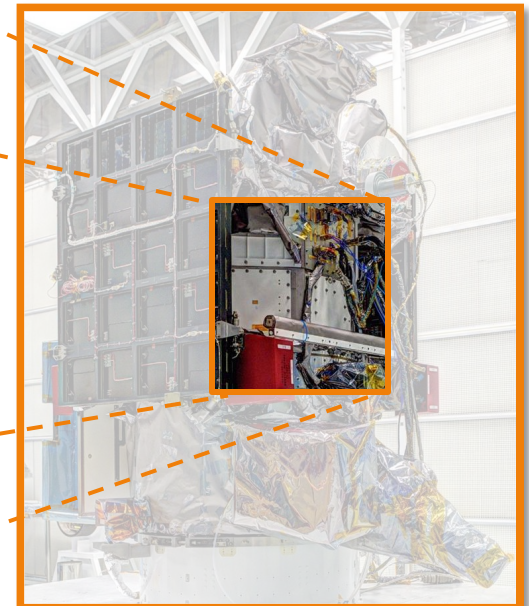
- **GSFC NS43C** is a white silicate based thermal control coating developed in the 1970s

- Applied on most of the radiator surfaces of DSCOVR (previously Triana) in the late 1990s

Thermal Property	
Solar Absorptance ( $\alpha_s$ )	0.20
Normal Emittance ( $\epsilon_N$ )	0.92

- NS43C coated surfaces were housed in a nitrogen purged storage environment for over a decade. This resulted in a **dry powdery aged coating** that generated particles during the refurbishment phases of the project (*contamination problems*)
- Physical signs of damage and “wear and tear” were also present. These damaged surfaces are fragile and thus, with continued handling were more susceptible to generate particles (*contamination problems*)
  - *For example, spots of bare aluminum due to coating removal and dark “scruff” marks*
- At the time, NS43C was the best available coating to meet thermal requirements and dissipate charge on radiator surfaces. However, NS43C is no longer being manufactured these days and have **outdated resistivity properties** (*electrostatic discharge problems*)
  - *Newer white silicate coatings exist to meet today’s mission requirements*

- NS43C coated surfaces were periodically vacuumed and gently wiped down by coatings experts to clean/remove loose particles
- Touched up bare aluminum spots on the radiators using Z-93C55. The non-repairable surfaces were stripped and re-coated with Z-93C55
  - ***Alion Z-93C55** is a white electrically dissipative silicate based thermal control coating with resistivity properties to meet today's mission requirements*
- Designated all white coating surfaces as “**no touch surfaces**” to minimize particle generation from handling through out the pre-launch phases of the project

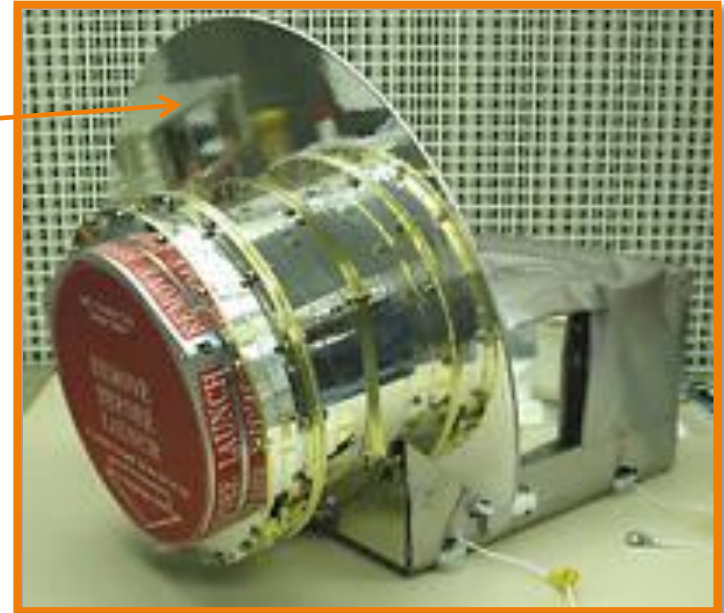
- **GSFC Silver Composite Coating (CCAg)** is a vapor deposited thin film coating consisting of layers of silicon oxide, aluminum oxide, and silver ( $\text{SiO}_2/\text{Al}_2\text{O}_3/\text{Ag}/\text{Al}_2\text{O}_3$ ). Layers of **Indium Tin Oxide (ITO)** may also be applied as a top layer for electrical conductivity purposes.
  - *Historically, CCAg is very robust (if applied properly) with a low chance of removal from the substrate. ITO is typically very fragile with a high chance of removal from surface damage.*

- Applied to the “peacock” shaped radiator on the **Faraday Cup** in the late 1990s
  - *DSCOVR’s Faraday Cup will monitor the speed and direction of positively charged solar wind particles*

Thermal Property	
Solar Absorptance ( $\alpha_s$ )	0.08
Normal Emittance ( $\epsilon_N$ )	0.72

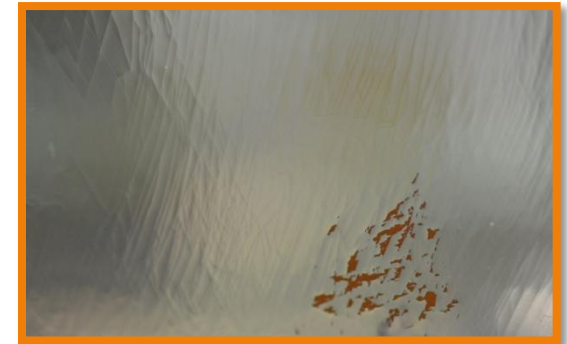
- Visible signs of crazing, micro-cracking, and delamination effects were discovered on the CCAg coated area of the peacock shaped radiator
- Due to its extended time in storage, the Kapton substrate probably retained some moisture, and thus caused adhesion issues between the CCAg and Kapton
- This adhesion anomaly increases risk due to the Faraday Cup's sensitivity to *particulate contamination* and *electrostatic discharge* (ESD) charging
  - *May pose a threat for the dispersion of conductive metal particles on the Faraday Cup*
  - *May have damaged or removed the ITO layer on the CCAg coating*

- Re-deposited ITO CCAg onto 3 mil Kapton and applied onto peacock shaped radiator of the Faraday Cup

- Apply reflective thin films onto metal substrate (or hardware surface) rather than Kapton to reduce impact of moisture damage when in storage for extended periods of time
